INSPECTIONS  
**RODRIGUES**

## Building Inspection Report

1234 Main Street

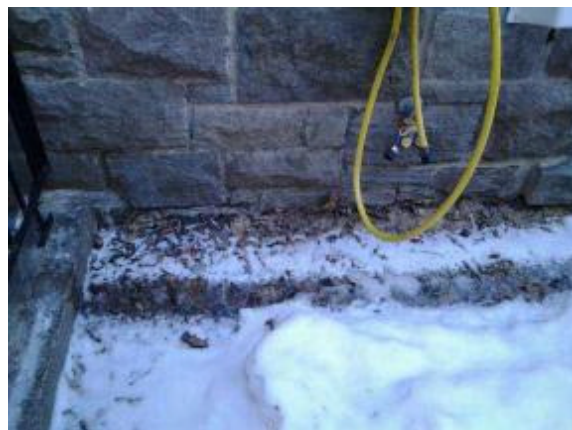
Weep holes are missing.

The ground is too close to the masonry wall. We recommend the installation of a drainage ditch, similar to that of a window well, to prevent water damage to the masonry walls and the structure behind the walls.

The lintels above the living room windows at the front have sagged, this is typical for a building of this age.

Consult a mason to inspect and determine the extent of work and cost of repairs for the following observations:

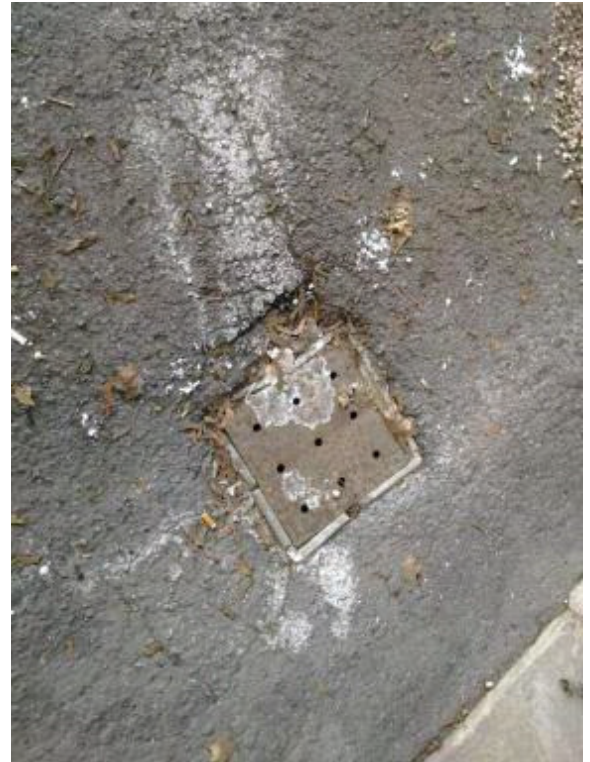
#### 2.4 DRIVEWAY

The driveway is functional but cracks, depressions/settlement, et oil stains were seen.

Consult a Specialist to determine the extent and cost of work for the following observations: A new concrete silt trap is recommended for the drain. Improper water control could allow water seepage under the home and the driveway.

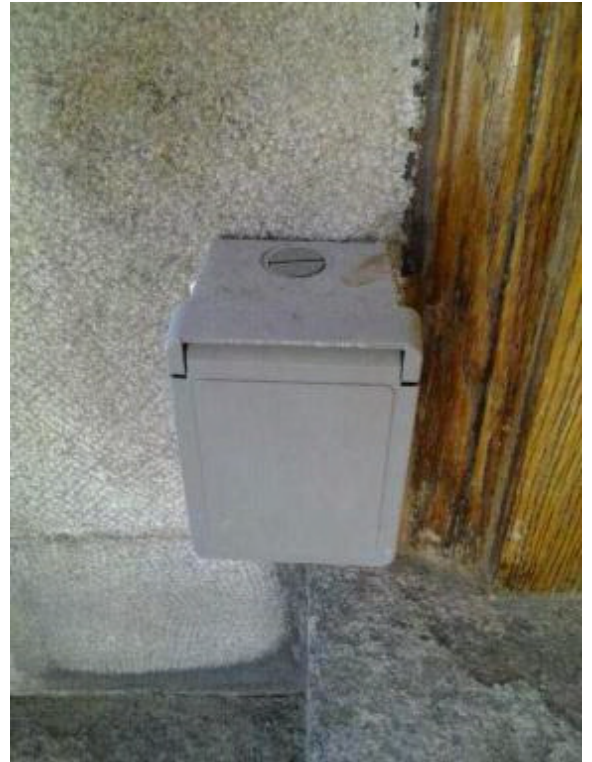
2.6 ELECTRICAL PLUG

Plugs are ungrounded,  
recommend grounding all  
exterior plugs and wires.

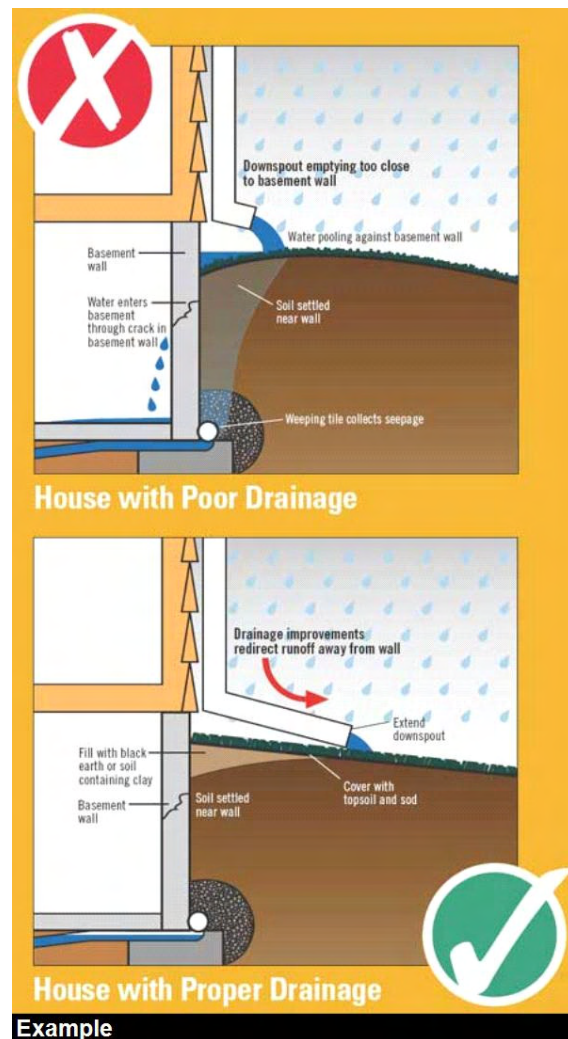
## 2.7 GRADING OF LAND AROUND THE BUILDING

Repair the grading of the land in order to shed water away from the foundation (6"/15cm above grade gradually sloped over 6'/2m). This is important to reduce the risk of water infiltration in the basement and to prevent structural problems.

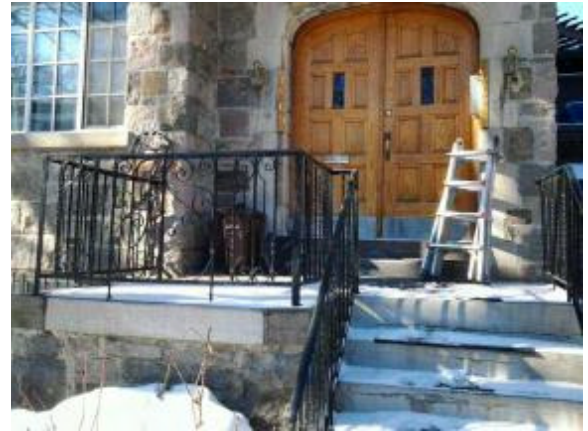
### 2.8 BALCONY 1

Consult a specialist to determine the extent and cost of work of the following observations: The railings are installed too low, falling hazard.

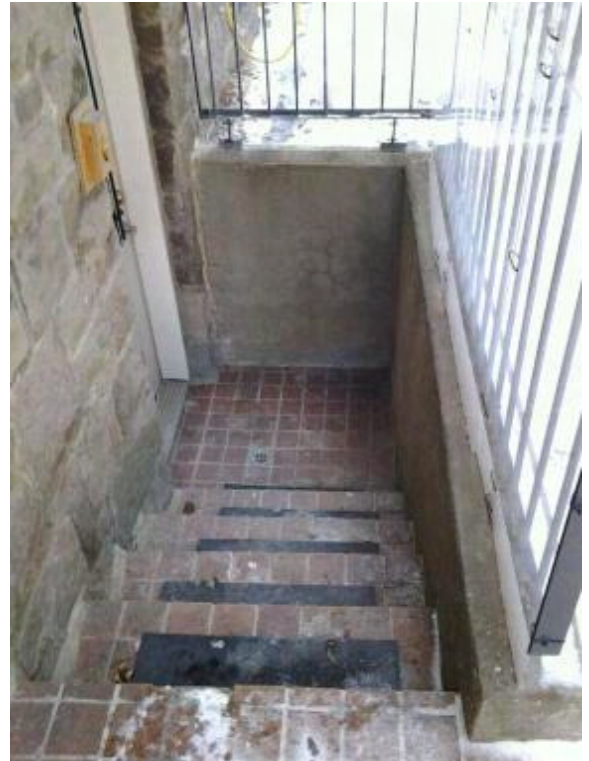
#### 2.12 EXTERIOR STAIRWELL

Railings are missing at the basement stairwell.

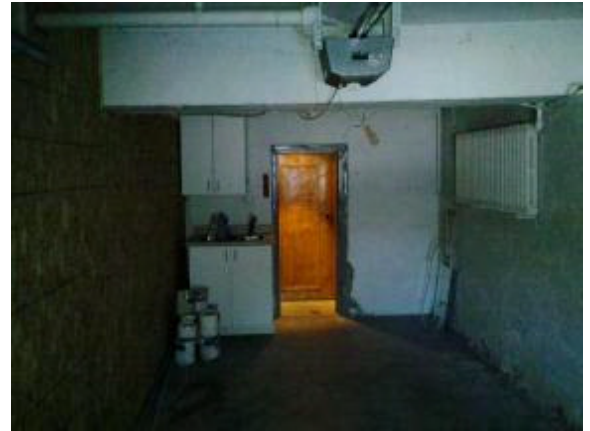
2.13 GARAGE

Recommend heating the garage to >60 degrees F (15 degrees C).

Updating of the garage door opener is recommended due to that fact that the present model does not have electronic eyes.

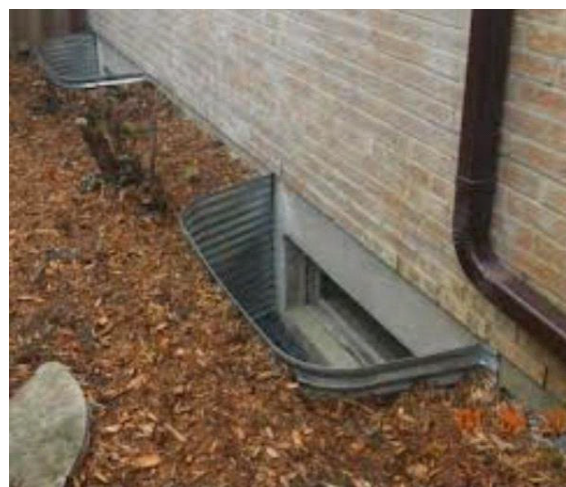
Basement window need better drainage we recommend the installation of window wells.

Consult a window repair company to inspect and determine the cost and extent of work required for the following items:

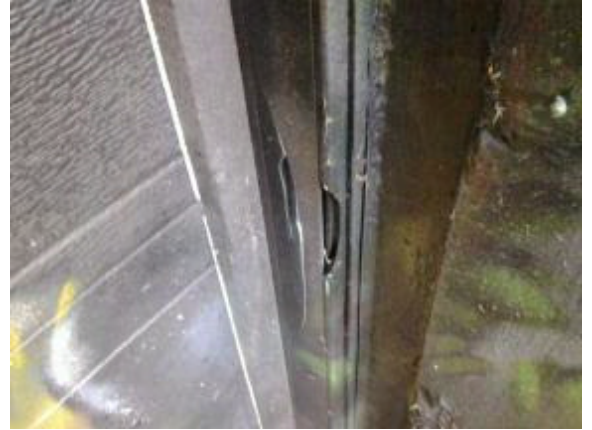
Minor damage on weather  
stripping.

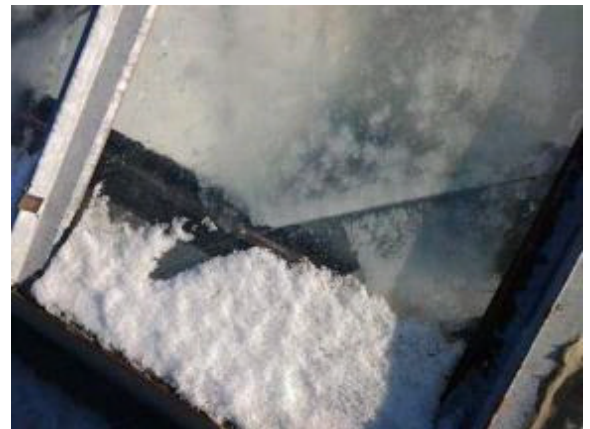
There are cracked panes. Temporarily seal them with silicone to prevent leakage. Replacement of panes is recommended.

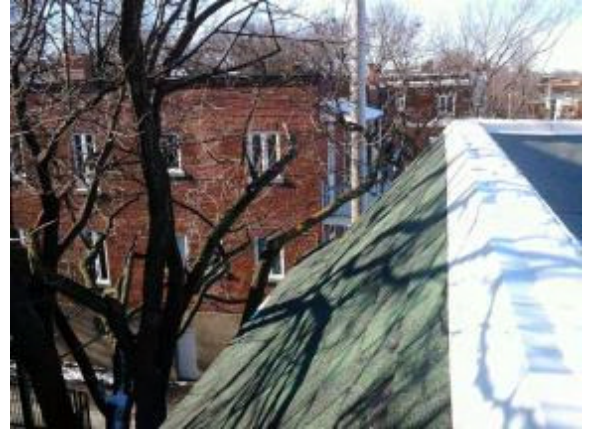
Eaves troughs are missing at all sides of the building. This condition adds to the risk of water infiltration and splash back onto the building.

Trim tree branches that risk  
touching the roof. Tree  
branches move with the wind  
and can rub and damage the  
roof coverings. These  
branches can be weighted  
down by snow and ice thereby  
increasing the damage they  
can cause. These branches  
can be used by vermin to get  
onto the roof and possibly, the  
attic.

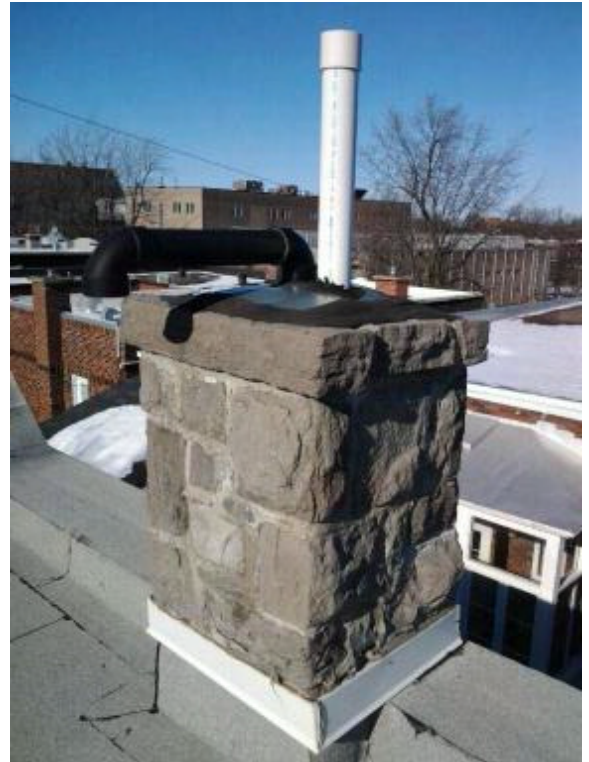
7.4 CHIMNEY 2 CONDITION

Some mortar repair visible; inspect and repair as required all joints annually.

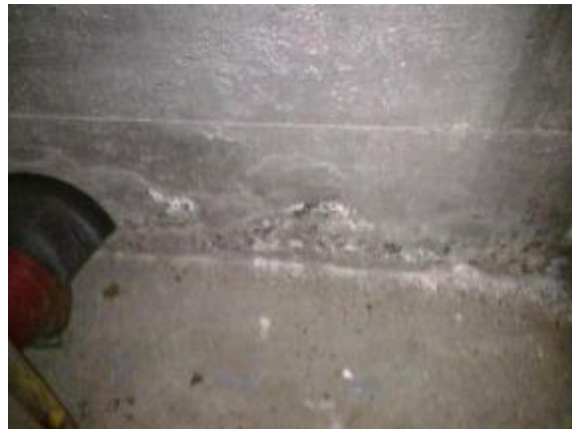
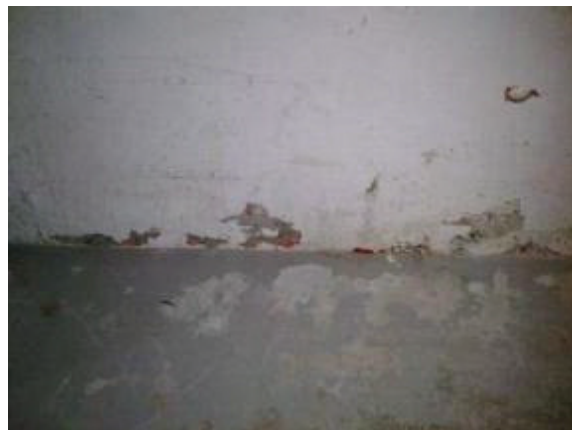
Efflorescence staining seen along the bases of the foundation walls. This may be an indication of blocked or non-existent french drains. Water is being absorbed by the foundation.

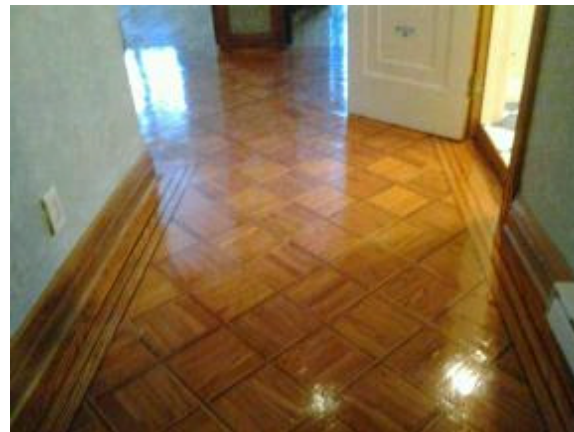
Humped floors were noted. This is often due to different shrinkage rates between the main beams and the wood floor joists, partition walls not resting on a main beam, buckling of floor boards, or a

warped floor joist. Sometimes it can be from slippage at a column or the joist connections at a beam. An engineering investigation would be needed to know for sure.

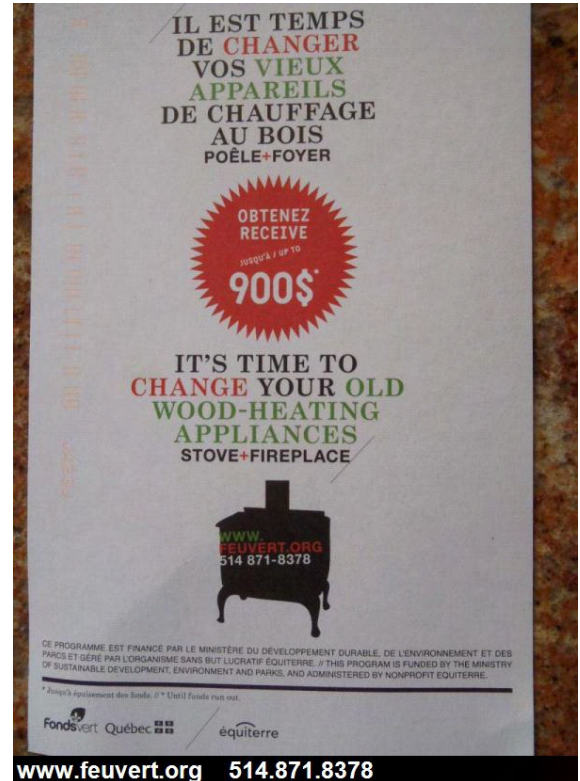
### 10.2 FIREPLACE 1 OBSERVATIONS:

Consult a chimney sweeper or specialist to inspect the fireplace in order to determine the cost and extent of repairs since we found:

This type of fireplace may not be compatible with the chimney provided.

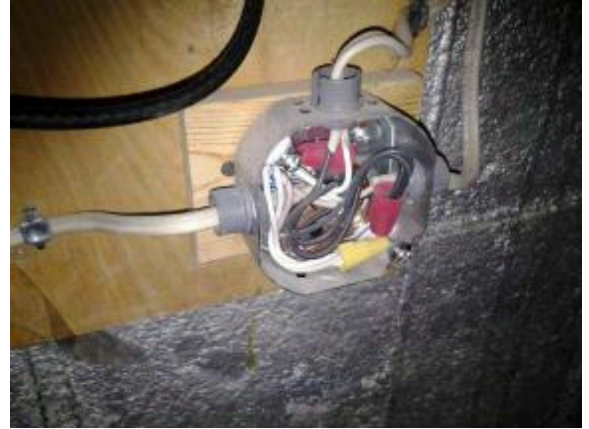
Junction boxes missing cover plates at the furnace room. A missing cover plate leaves energized electrical components exposed to touch. Install cover plates.

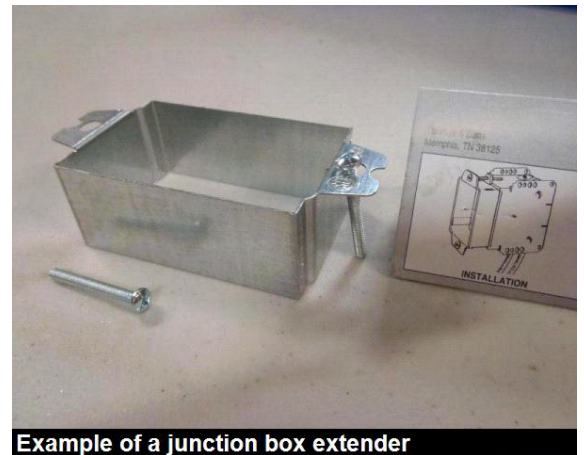
Recessed plugs at the kitchen counters. The electrical junction boxes were not moved forward nor extended thereby creating a space where sparks can escape. The electrician should check the switches as well.

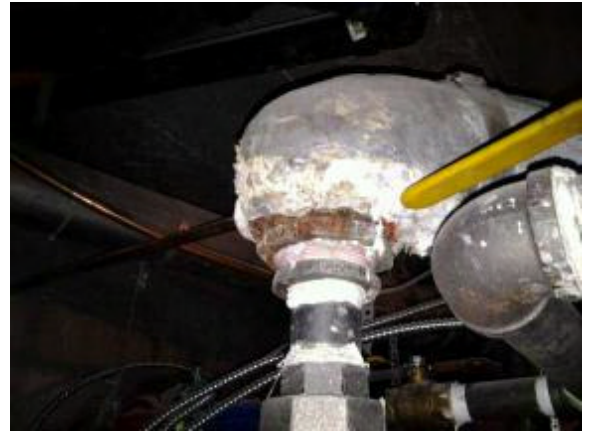
Asbestos looking material  
seen on heating pipes in the  
basement. Encapsulation or  
removal is recommended.  
Consult a specialist.

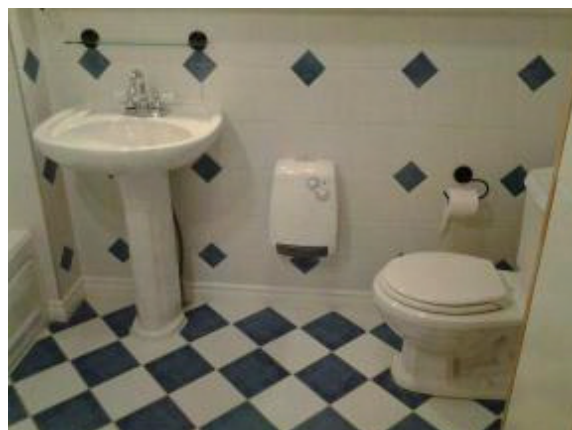
Recommend sealing the corners of the bathwall with silicone.
