INSPECTIONS  
**RODRIGUES**

## Building Inspection Report

1234 Main Street

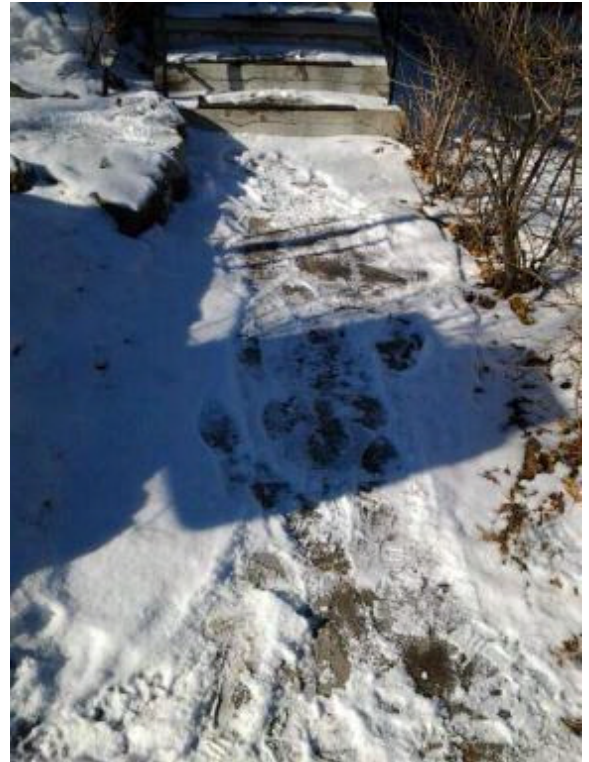
The walkway is not visible due to snow and ice. This impedes our visual inspection.

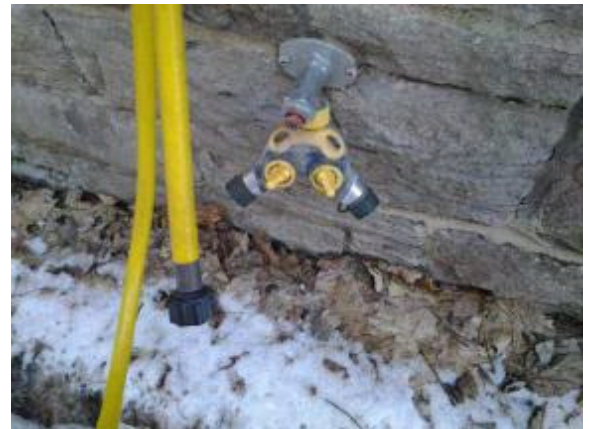
An exterior hose bib was located at the left hand side of the building.

The hose bib was not operated due to the weather being too cold to operate the hose bib safely.

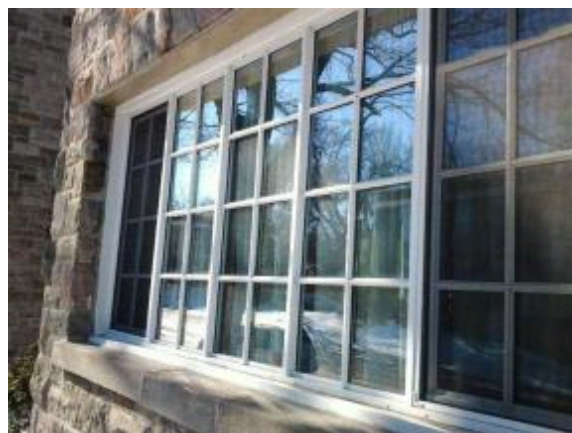
### 3.1 WINDOWS

Windows are a newer installation. Windows have thermal panes.

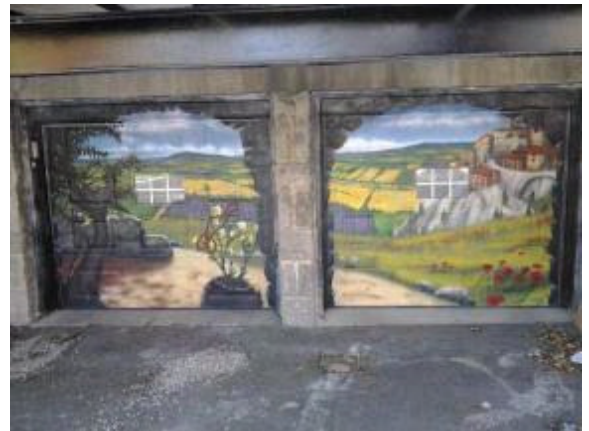
Minor damage on weather  
stripping.

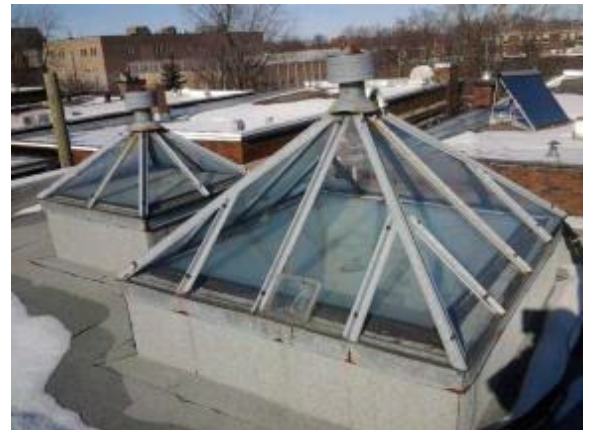
#### 5.6 SKYLIGHTS

There are cracked panes. Temporarily seal them with silicone to prevent leakage. Replacement of panes is recommended.

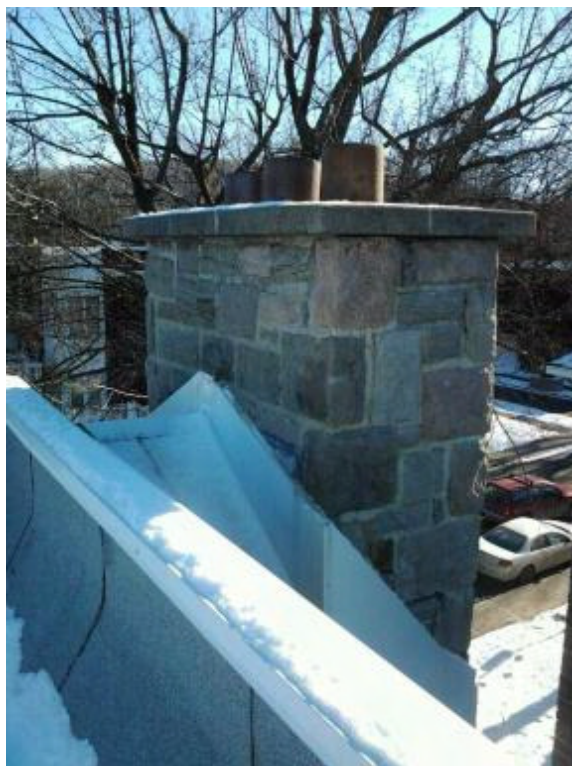
12. Some mortar repair visible; inspect and repair as required all joints annually.

Missing a rain cap. Exposed flue to rain could have caused damage to the liner or other sections of the chimney not visible during an inspection.

Some mortar repair visible; inspect and repair as required all joints annually.

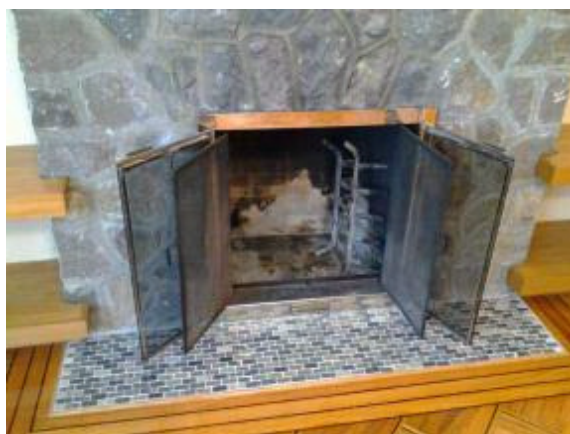
The combustion chamber or firebox needs some mortar pointing repair.

This fireplace should not be used until it is repaired. Hazardous.

The fireplace is located at the living room.

The fireplace is a masonry fireplace.

2. It would be best to convert the fireplace to a sealed gas/propane type of fireplace. These are safer, easier to maintain, can heat the building, and are more environmentally friendly.

Consult a chimney sweeper or specialist to inspect the fireplace in order to determine the cost and extent of repairs since we found:

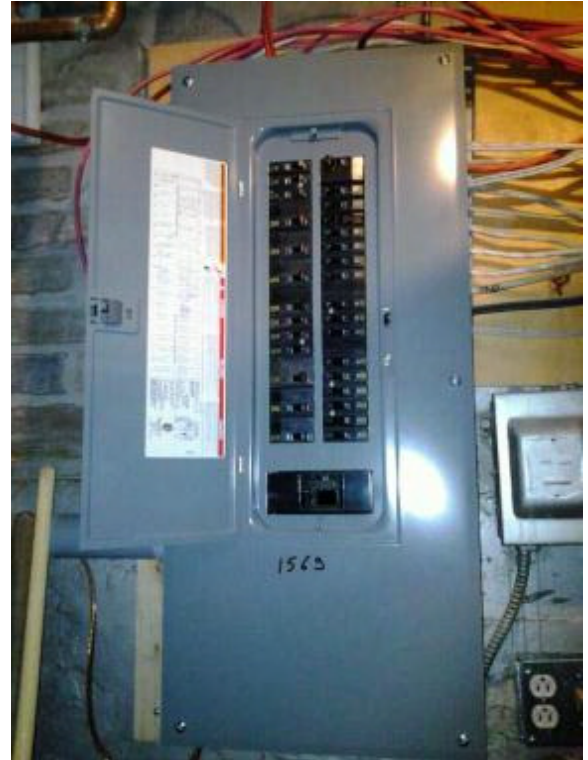
The main circuit panel capacity is full. This means that any additional circuits will require the upgrading of this panel or the installation of a sub-panel.

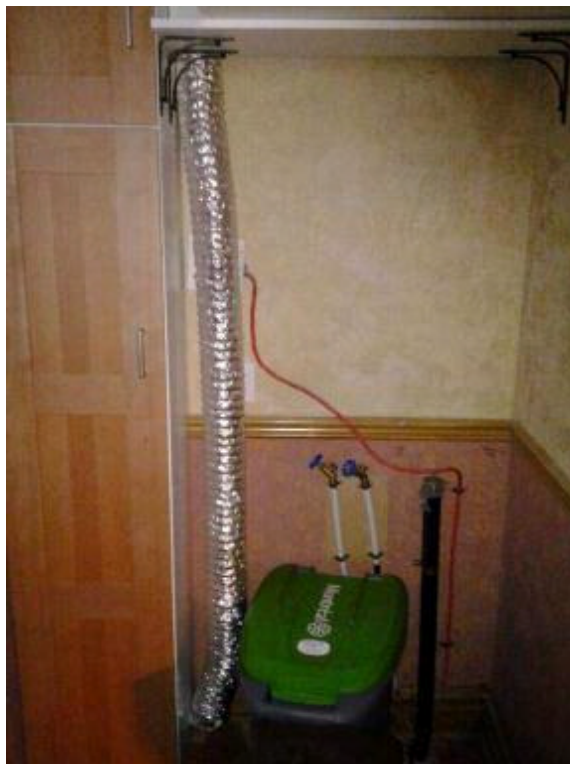
Dryer vents to the exterior.

Washer has a dedicated drain.
